Renovation and extension sports center, Gstaad

2018

Gstaad has made its sports center fit for the future. In addition to the construction of a wellness area, the wooden support structure of the indoor swimming pool was extensively renovated. Timbatec analyzed its condition and defined the renovation measures.

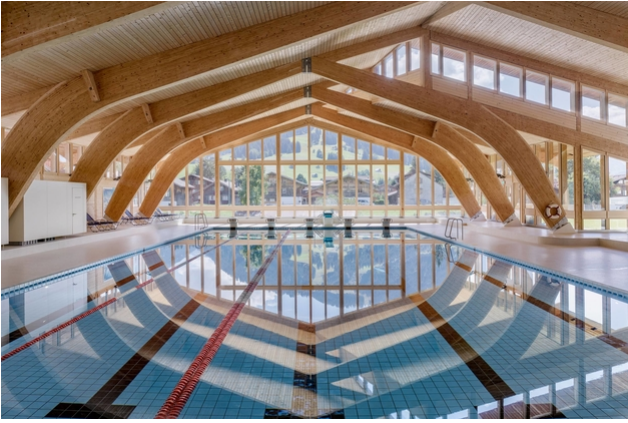
Impressive dimensions: supporting structure of the indoor swimming pool

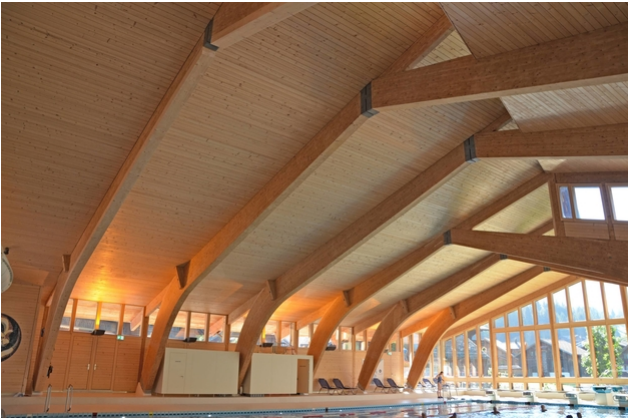
The beam on the far left is additionally reinforced with slats

In order to reinforce individual trusses, lamellas made of glulam were glued on. In addition, the roof was thermally renovated. The boarding between the trusses was removed, the roof was insulated from the inside and provided with a new formwork. Timbatec was responsible for quality assurance of the refurbishment work and also for fire protection for the entire project.

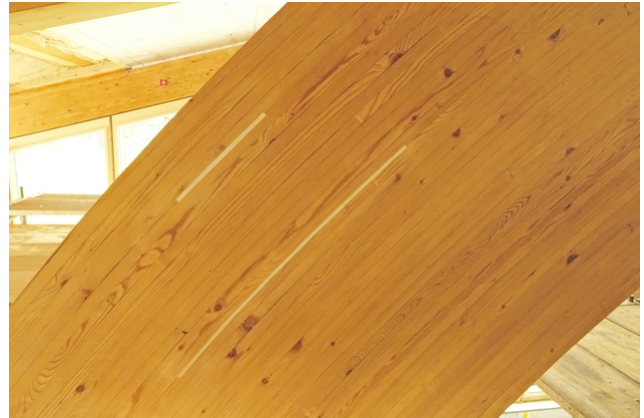
Detailed view of a rehabilitated adhesive joint

The Gstaad indoor swimming pool, built in 1971, is the oldest indoor swimming pool in Switzerland with a three-hinged arch supporting structure made of glulam. The pool has been a listed building for some time. The dimensions of the construction are impressive. The supporting structure consists of three-hinged arch trusses with spans of up to 34.2 meters and cross sections between 20 x 110 cm and 35 x 135 cm. But age has left its mark. Building technology, the drains as well as the building structure were partly outdated. In addition, cracks had appeared in the main supporting structure of the roof. Timbatec received the order to investigate the cracks. They were recorded and documented with a total station. It was found that certain cracks were so deep that the statics were no longer guaranteed. It was also found that the load on the main girders was too high in some areas. Crack repair was therefore necessary on the girders. The cracks were cut free, cleaned and adhesive was injected to close them.
